## St Mary's Church, Orton Waterville

### Dampness in the Tower

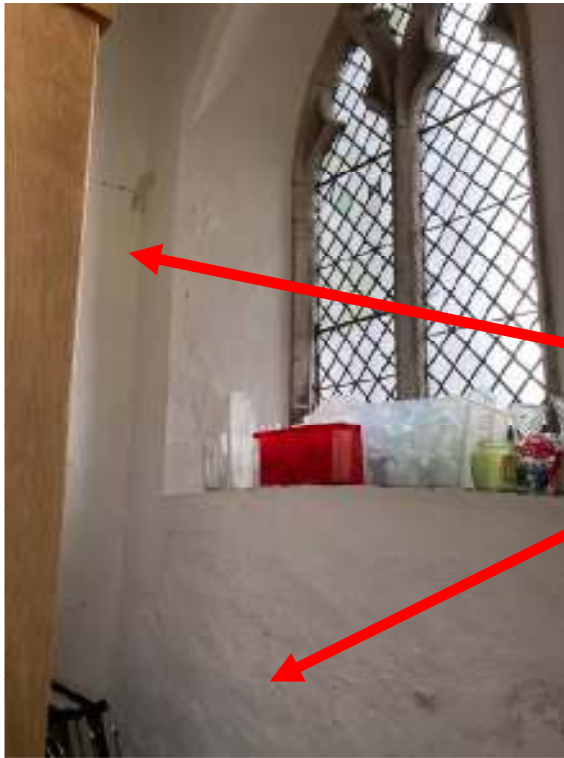
**Stonework can be up to 38% water content. (West facing wall, adjacent to WC.)**

**20% to 38% moisture content in this area here.**

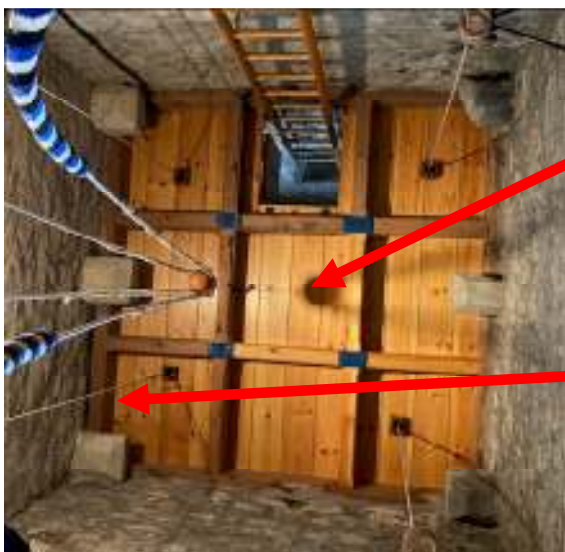
**Tower timbers can be up to 22% water content.**

**This is the Tower ceiling, looking up.**

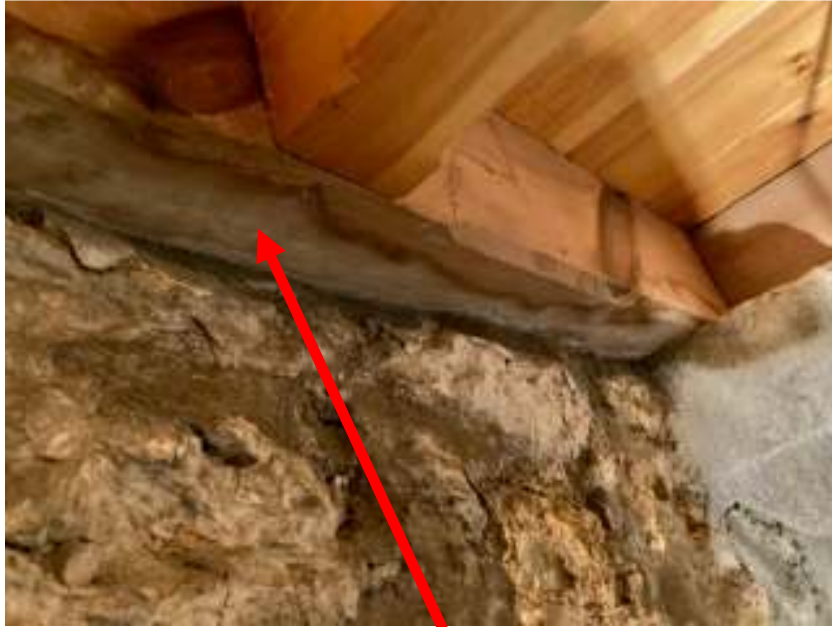
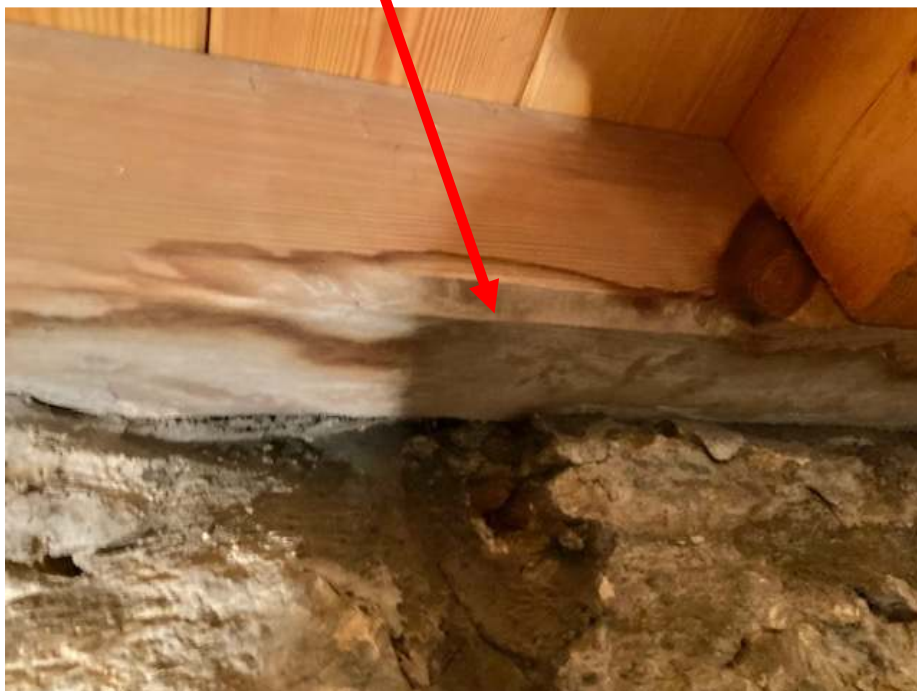
**We take a closer look at the easterly facing structural floor timbers:**

**We find water staining on the timber surfaces.  
Moisture levels in excess of 15% require attention,  
otherwise rot and/or insect infestation is a real risk!**

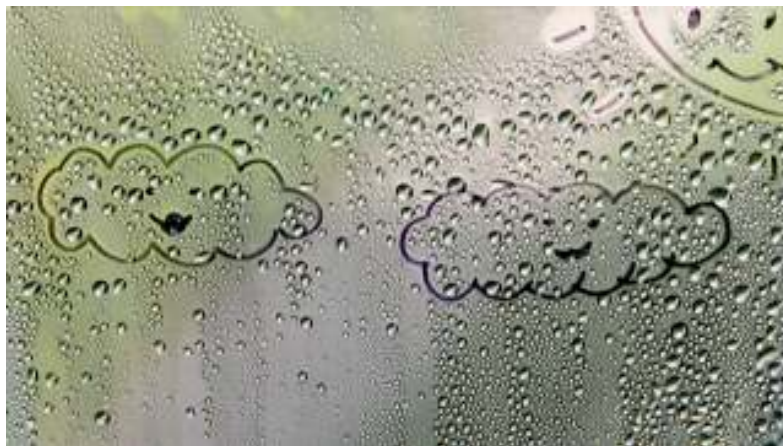
**We suspect that the Tower render is not "breathing" and is holding water within! A condition like keeping it sealed within a plastic bag!**

**"The current render has a range of 1 part cement to 2 parts sand. It is thick, dense and entirely waterproof. The consequence is that it is impossible for all the water percolating from the top of the walls to evaporate externally."**

- 1. Remove the entire external render from the lower floor. It is cement and not a traditional material. Removal will be difficult and will require use of power tools.**
- 2. Replace with the traditional Lime render. Can only be carried out in fine weather conditions**
- 3. Budget cost £30,000**
- 4. The Diocese have approved our strategy in principle.**

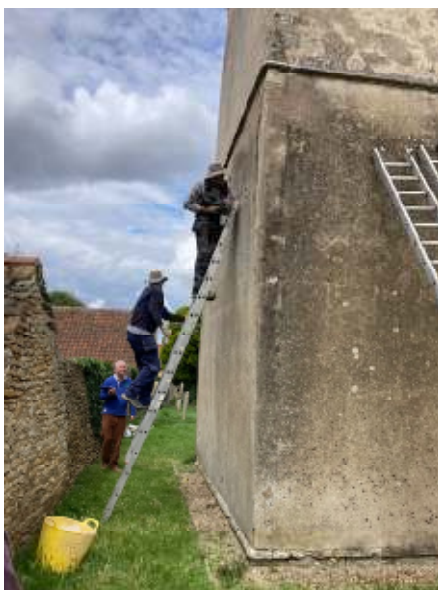
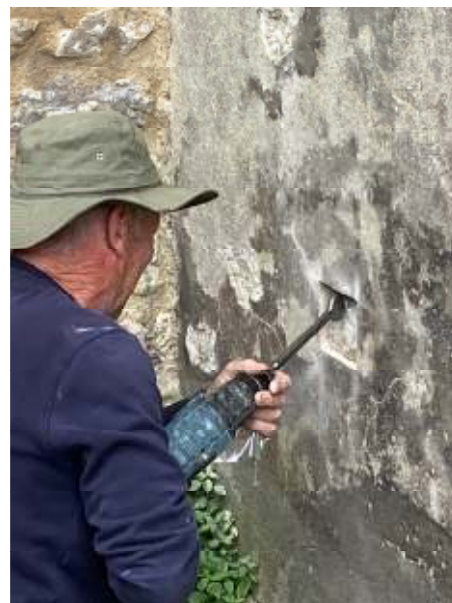
**We have taken samples of the render and sent them to a laboratory for analysis.**
